Client: 23055A Grand Firs HOA

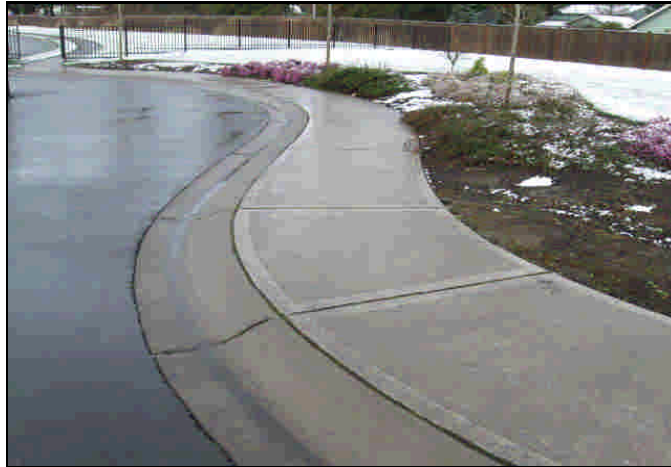
**Comp #:** 100 Concrete/Curb - Repair/Replace

**Evaluation:** Common area concrete at sidewalks, curbing and roadway gutters is in good condition, with no significant damage or deterioration observed. All concrete surfaces within individual unit boundaries is reportedly the responsibility of individual unit owners to maintain, repair and replace. Sidewalks, curbs and gutters adjacent to roadways and any concrete within parks is association responsibility.

As routine maintenance, inspect regularly, pressure wash for appearance and repair promptly as needed to prevent water penetrating into the base and causing further damage. Repair any trip and fall hazards (1/2" or more displacement) immediately to ensure safety.

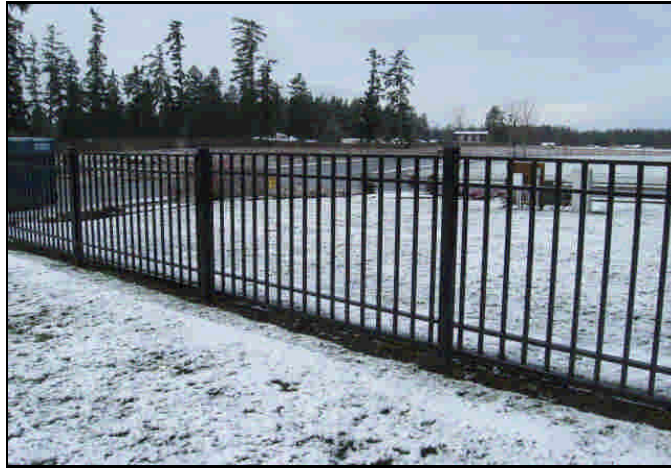
**Comp #:** 112 Metal Fencing - Repair/Replace

Evaluation: Generally good condition of metal fencing and pedestrian gates noted with no significant damage or instability evident at this time. Sturdy item that can typically last for an extended period with ordinary care and maintenance. In our experience, however, eventual replacement is warranted due to constant wear, usage and exposure over time. Plan to replace at roughly the time frame below. No anticipation of refinishing of this type of powder coated fencing at this time. Timeline for future painting is difficult to predict, suggest possible inclusion into future reserve study update. As routine maintenance, inspect regularly to ensure stability of fencing and repair promptly as needed from general operating funds.

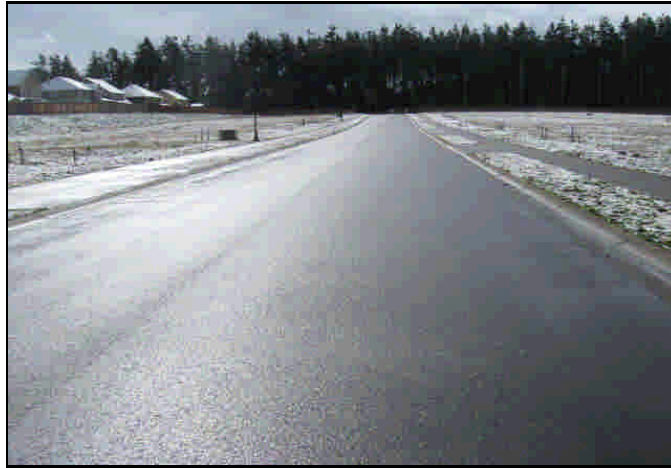
**Comp #:** 120 Asphalt - Resurface

Evaluation: The structural integrity of the private roadways appears to be in good condition. No cracking, waviness or other issues noted. We assume installation per engineering plans & spec's.

As routine maintenance, keep roadways clean, free of debris and well drained; fill/seal cracks to prevent water from penetrating into the sub-base and accelerating damage. Even with ordinary care and maintenance, plan for eventual large scale resurface (grind & overlay) at roughly the time frame below. As timing draws nearer, consult with asphalt vendor/consultant for recommendations and complete scope.

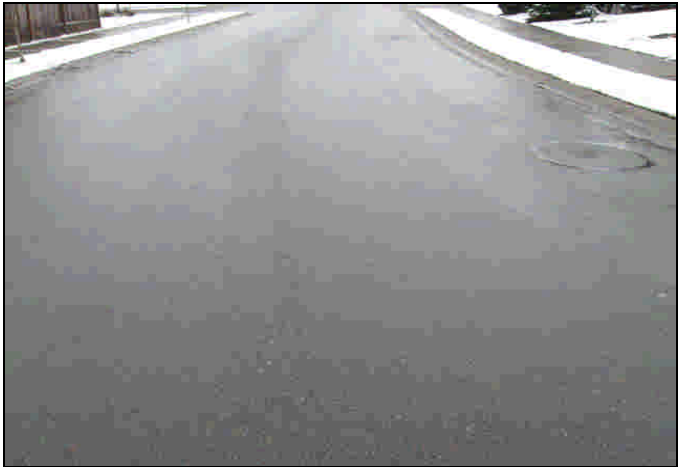
**Comp #:** 121 Asphalt - Seal/Repair  
**Quantity:** Approx 650,000 square ft  
**Location:** Roadways throughout community

**Evaluation:** Good surface condition noted with no significant damage/deterioration observed. We were informed that asphalt has not been seal coated. We usually recommend regular cycles of seal coating for low traffic roadways; however, cambered surface configurations such as yours are not typically seal coated because of the inherent drainage provision.

As routine maintenance, fill cracks and clean oil stains promptly to avoid further damage. Treat local repairs as general maintenance expense. Funding for asphalt seal coating or periodic repair may be added to future reserve studies as needed/desired.

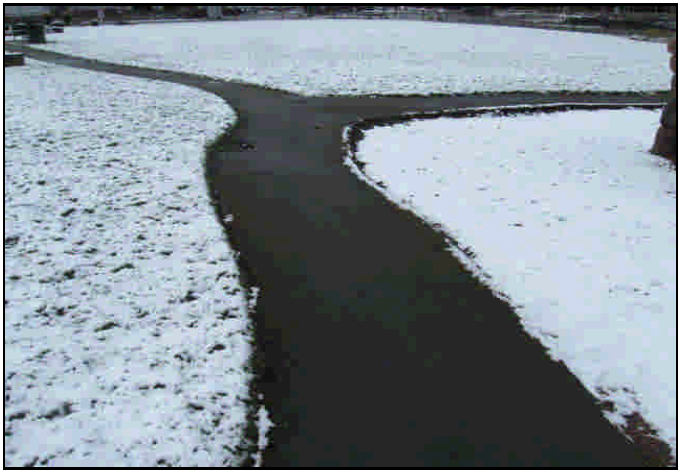
- Comp #:** 122 Asphalt Paths/Courts - Resurface
- Quantity:** Approx 9,200 square ft
- Location:** Basketball courts and pathways at common area parks in Tracts B, E, L and R
- Evaluation:** Good condition throughout with no significant damage observed. We recommend regular inspections, repair and cleaning of asphalt pathways and basketball courts to help extend useful life cycles. Plan for regular intervals of resurface (overlay) of asphalt pathways and basketball courts at roughly the time frame indicated below.  
Resurface these areas as part of roadway resurface project, no need for separate funding.

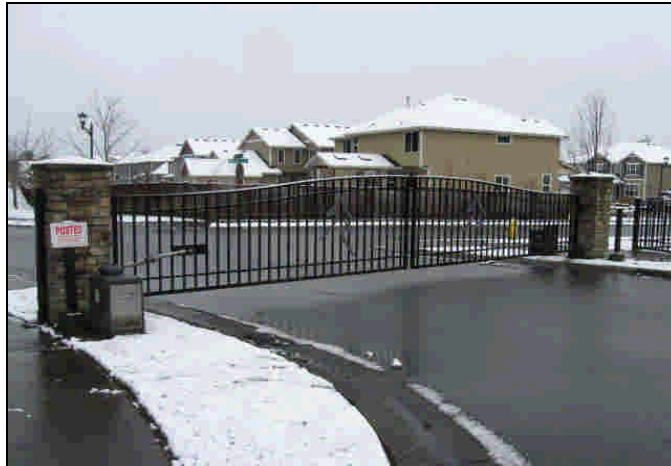
**Comp #: 135 Entry Gates - Repair/Replace**

Evaluation: Good condition noted of physical components of metal entry gates observed during our site inspection. We recommend regular professional inspections, maintenance and repairs to help extend useful life cycle; clean for appearance and paint/touch-up as needed within general maintenance / operational funding. Although metal gates are typically durable, we recommend setting aside funding for replacement if the need arises. Replacement may eventually be needed due to ordinary wear/usage, exposure or damage not covered by insurance.

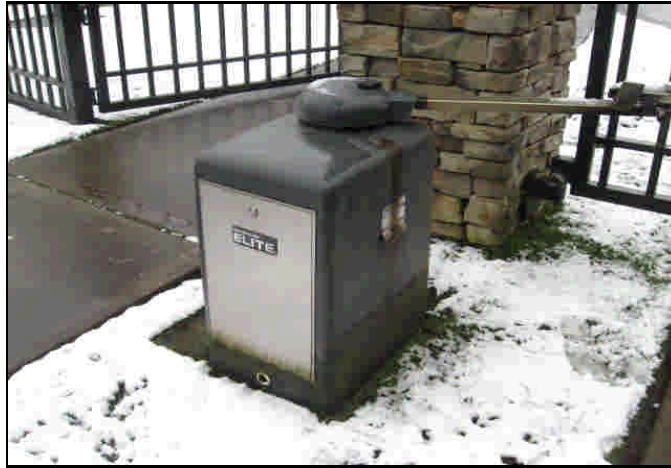
**Comp #: 136 Entry Gate Operators - Replace**

Evaluation: Fair condition noted with no functional/operational problems observed during our site inspection and no reported problems. As routine maintenance, we recommend regular professional inspections including service and repair as needed from the operating budget. Even with ongoing maintenance, plan for replacement at typical life expectancy indicated below. Monitor actual expenses closely for future reserve study updates.

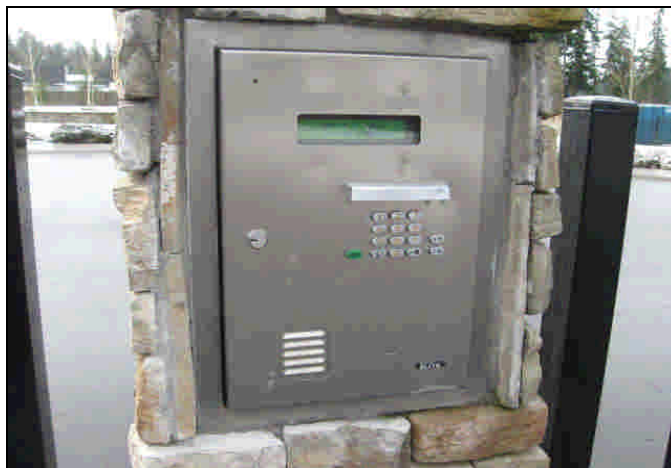
**Comp #: 137 Gate Access Panels - Replace**

Evaluation: Fair condition noted, with no functional issues observed during our site inspection and none reported to us. We recommend regular, professional inspections and maintenance funded from the operating budget; wipe down surfaces periodically with an appropriate cleaner for appearance, being careful to avoid control buttons. Best to plan for replacement at typical interval below, due to constant usage and exposure to weather elements.

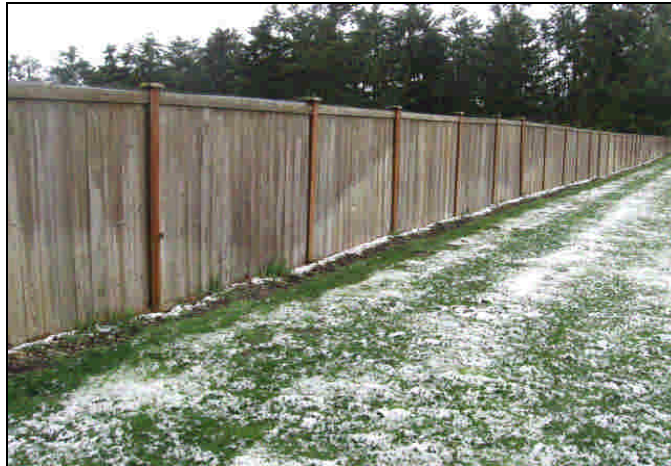
**Comp #:** 140 Wood Fence - Replace

Evaluation: Majority of wood fencing is in good condition with some areas of minor damage and past repair, but no significant deterioration noted. Fence appears to have never been stained or treated and is being allowed to gray naturally. As routine maintenance, inspect regularly for any damage and repair as needed. Avoid contact with ground, sprinkler patterns and surrounding vegetation. Regular cycles of stain/paint will help to maintain appearance and maximize life and can be added to reserve funding in the future if Association desires. Plan to replace at roughly the time frame indicated below.

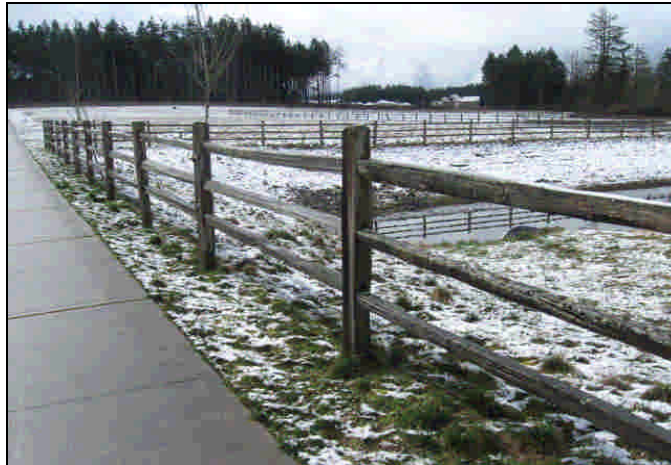
**Comp #: 145 Split Rail Fence - Replace**

Evaluation: Split rail fencing is in generally good, stable condition. Assumed that this will not be sealed and left to weather/age naturally. Avoid contact with surrounding landscape if possible. Repair in between replacement cycles as needed from operating budget. Plan for replacement at roughly the time frame indicated below.

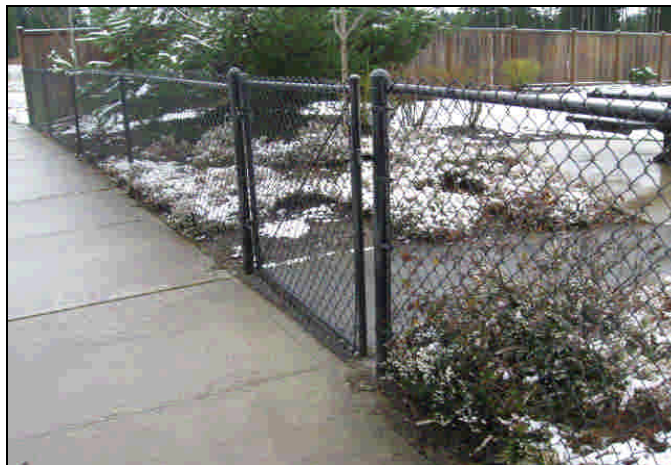
**Comp #: 155 Chain Link Fence - Replace**

Evaluation: Fair condition noted with some damage to fencing at park in Tract L, but no widespread deterioration observed. Inspect regularly; clean and repair locally as needed as part of general maintenance, operating funding. Even with ordinary care and maintenance, plan to replace this fence as shown below due to deterioration that will result from constant exposure.

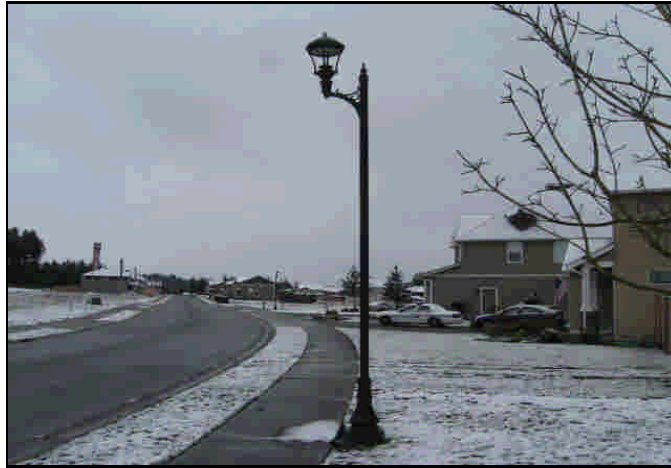
**Comp #:** 160 Pole Lights - Replace

Evaluation: Pole lights appear to be in good, stable condition, no problems or concerns reported. Observed during daylight hours; assumed to be in functional operating condition. As routine maintenance, inspect, repair/change bulbs as needed. Best to plan for large scale replacement at roughly the time frame below for cost efficiency and consistent quality/appearance throughout association.

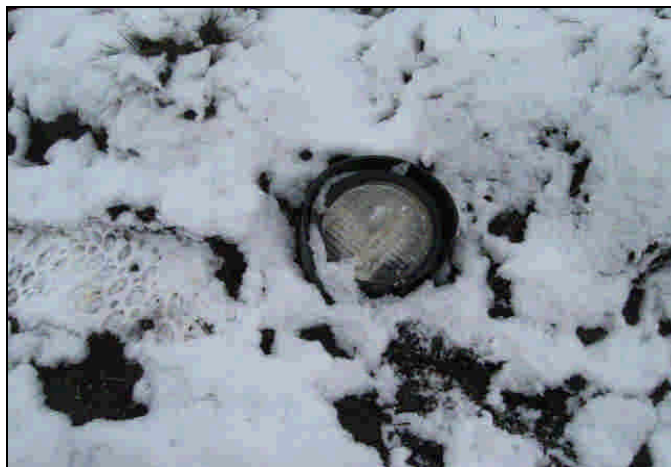
**Comp #:** 164 Landscape Lights - Replace

Evaluation: Mostly fair condition with no significant damage/deterioration noted during our site inspection; observed during daylight hours and assumed to be functional. Inspect regularly and change bulbs as needed. Plan on cycles of full replacement at roughly the time frame indicated below due to constant exposure to the elements.

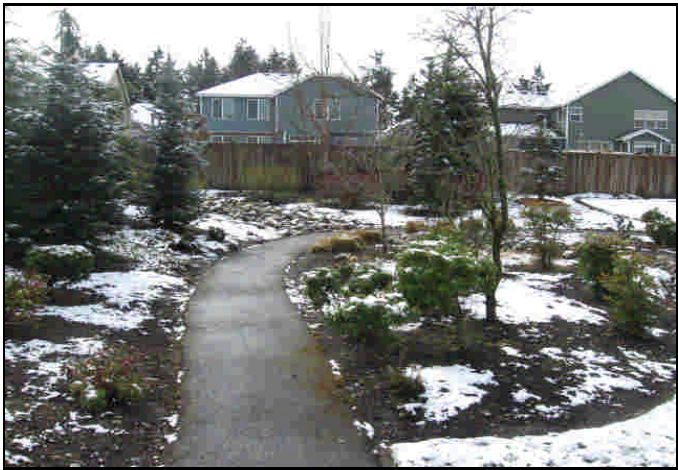
**Comp #:** 170 **Landscape - Refurbish**  
**Quantity:** Extensive landscaping  
**Location:** Common area open space tracts throughout community  
**Evaluation:** Overall good condition of common area landscaping with no specific problems observed or identified by association contact. Although typically funded as ongoing maintenance item, this component may be utilized for setting aside funds for larger expenses that do not occur on an annual basis, such as large scale plantings, resodding lawn areas, bark/mulch replenishment, etc. Often times these type of projects can be handled within the annual operating budget as a separate line item from the landscape maintenance contract. At this time no specific projects anticipated and no desire by community for refurbishing. Monitor and include funding in reserve study updates if needed.

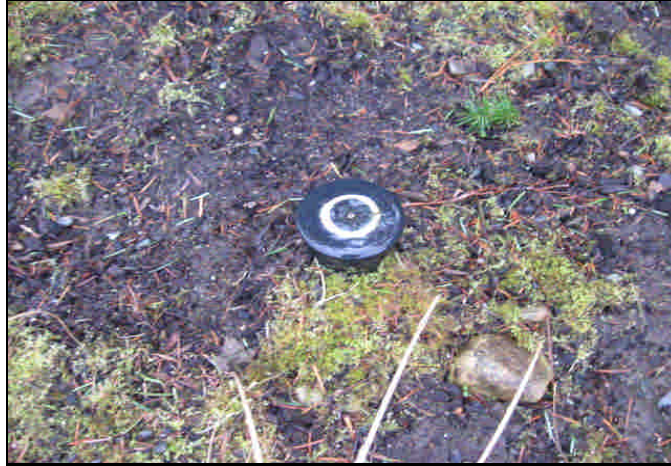
**Comp #:** 175 Irrigation System - Repair/Replace

Evaluation: No problems observed or reported during our inspection. As routine maintenance, inspect, test system and repair as needed from operating budget. Follow proper winterization and re-energize procedures. If properly installed and bedded without defect, the lines will last 40 to 50 years or more. Other elements within this component are generally low cost (i.e. sprinkler heads, valves) and have a failure rate that is difficult to predict; best suited to be handled through the operating budget, not reserves. No basis for reserve funding at this time.

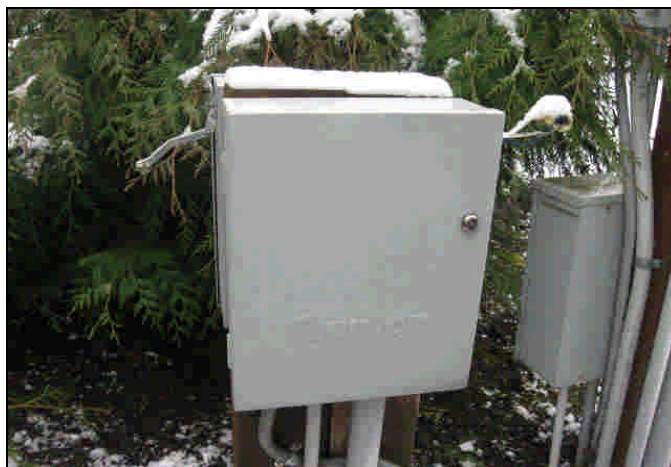
**Comp #:** 176 Irrigation Timeclocks - Replace

Evaluation: No problems observed or reported of irrigation timeclocks throughout community. Inspect regularly and repair/replace as needed. Expect intermittent failures and necessary replacement due to parts obsolescence, technological upgrades, etc... Plan on replacement at roughly the timeframe indicated below.

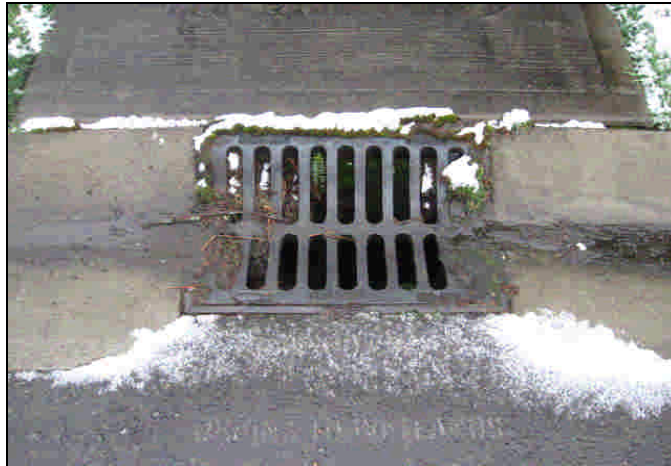
**Comp #:** 182 Drainage/Stormwater Sys - Maintain

**Evaluation:** Our reserve study includes only a visual review, and majority of the drainage system is out of view. No current drainage problems observed or reported. As routine maintenance, inspect regularly, keep drains and grates free of debris and free flowing to ensure water drains as designed. Pipes can be 'scoped' to allow visual review of the interior of pipes. Repair as needed, including pumping out sediment, if needed, utilizing mobile evacuator service. Fund from operating and maintenance budget. No expectation of large-scale repairs/replacement at this time. No reserve funding suggested.

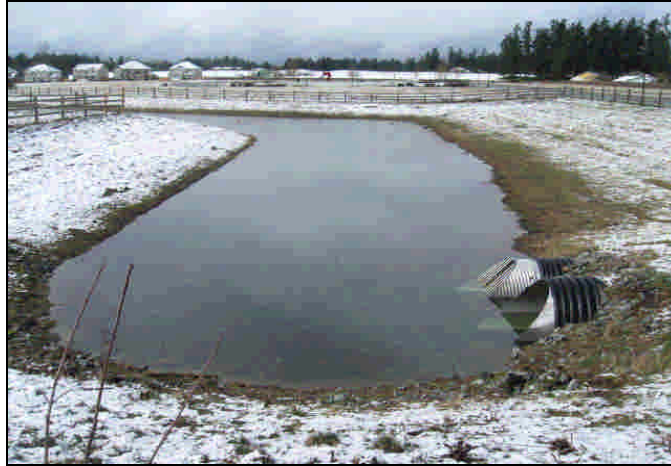
**Comp #:** 185 Stormwater Ponds - Clean/Refurbish

Evaluation: No problems noted at ponds throughout community. Ongoing maintenance program and close inspection is essential for performance and forestalling sediment removal. We assume ongoing vegetation and debris control as routine maintenance procedure. Guidelines for maintaining these systems are typically found on local municipality website. Even with proactive cleanings/inspections, debris will eventually build up raising floor and warranting sediment removal. Best to plan for sediment removal and repair of ponds at the interval below; ponds should be professionally assessed before this time for more specific guidance.

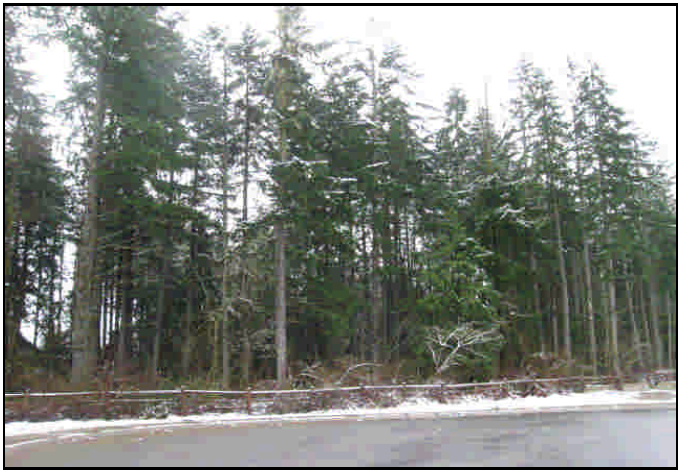
Comp #: 188 Wetlands - Maintain

Evaluation: No problems observed in wetland areas based on our boundary area inspection. We recommend compliance with any and all governmental regulations regarding these areas. Typically wetland areas are to remain undisturbed in a substantially natural state; periodic hazard tree removal is typically allowed. No basis for large scale reserve funding suggested at this time.

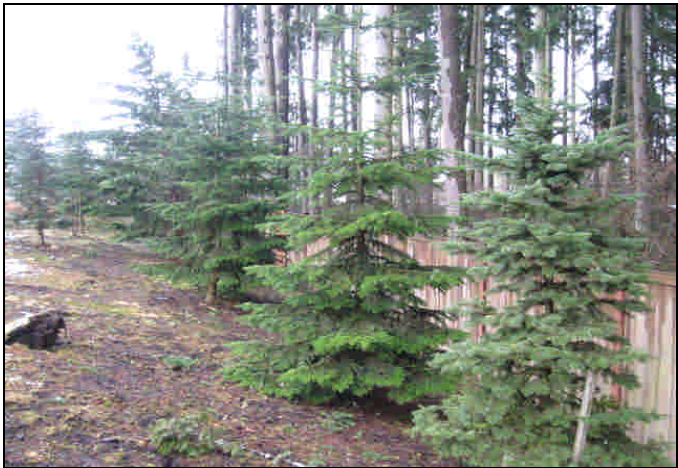
Evaluation: No specific problems observed or reported at this time of trees throughout community. It is our understanding that the maintenance of trees on individual lots is the responsibility of the individual homeowner and the Association is only responsible for trees at common area open space tracts. In similar communities, we have seen trees planted in planter strips between roadway and sidewalks needing to be replaced at roughly the 10-year mark of life. The main reason for replacement being the wrong species of trees planted for a small growth area and generally less than favorable planting location. If the wrong species are planted, the root systems can cause damage to the nearby concrete and asphalt, or the trees themselves may die prematurely due to confined root systems. If the community has not already done so, consult with a qualified arborist for a long-term plan for the care and management of the trees within the community, balancing aesthetics with protection of association assets. Tree trimming/removal expenses can be incorporated into future reserve study updates as needed.

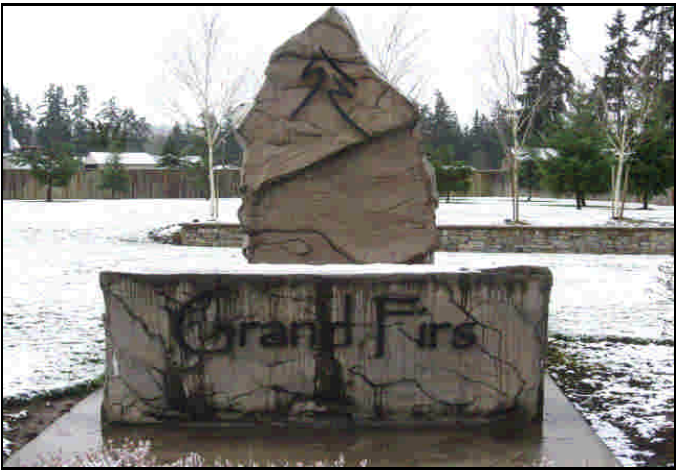
Comp #: 200 Entry Monuments - Replace

Evaluation: Good condition of entry monuments consisting of stone monoliths with attached lettering. As routine maintenance, inspect regularly, clean for appearance and repair as needed from operating budget. Long-lasting material, no expectation of cyclical large scale expenses impacting reserves at this time, no reserve funding suggested.

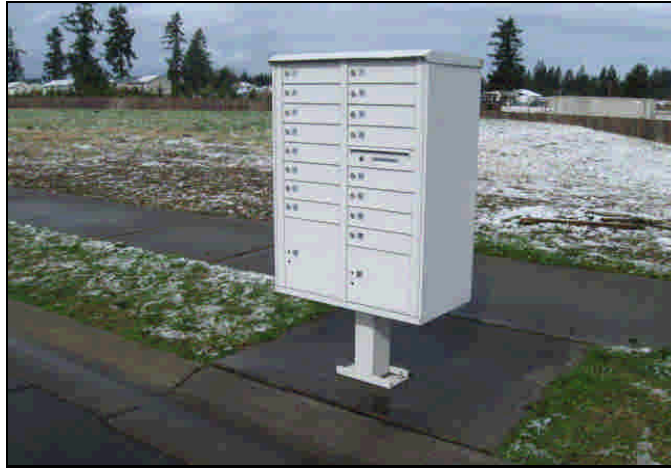
**Comp #:** 205 Mailboxes - Replace

Evaluation: Good condition of metal cluster stands/boxes with no functional problems reported. Inspect regularly, clean by wiping down for appearance, change lock cylinders, lubricate hinges and repair as needed from operating budget. Best to plan for total replacement at roughly the time frame below due to constant exposure, usage and wear over time. Note: USPS has a limited budget for replacement and should not be relied upon for purposes of long term planning.

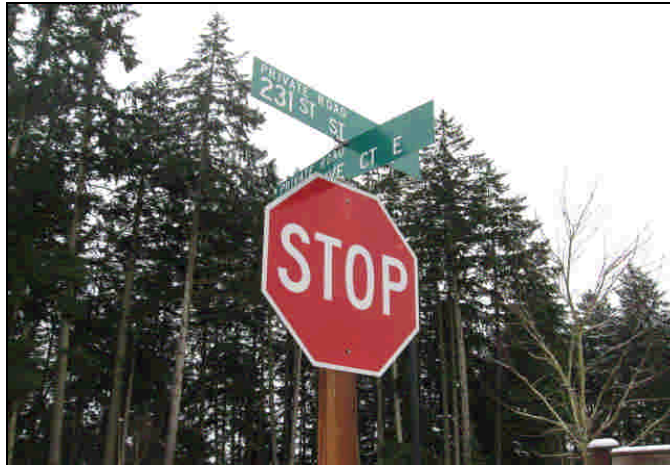
**Comp #: 210 Required Signage - Replace**

Evaluation: The majority of signage appears to be in good condition. Inspect regularly, clean for appearance and repair as needed from operating budget. These types of signs are a smaller cost item, but collectively merit reserve funding.

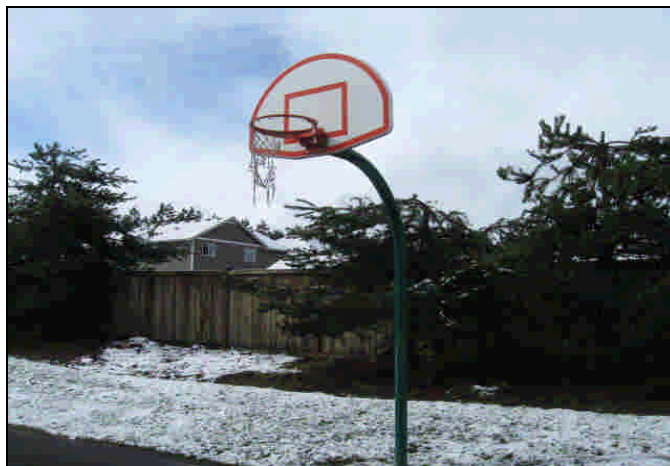
**Comp #: 330 Basketball Eqp - Replace**

Evaluation: Fair, playable condition observed. Inspect regularly and repair/replace net/hoop as needed within annual operating budget. Although sturdy materials/equipment, plan for eventual replacement at the time frame below if not damaged or abused.

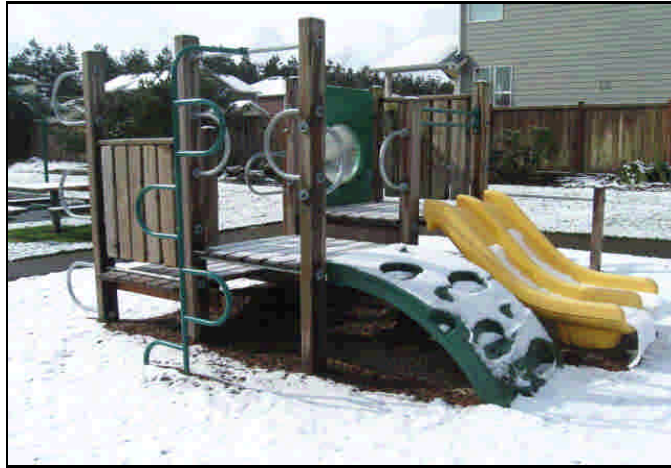
**Comp #:** 340 Play Equipment - Replace

Evaluation: Fair condition with no significant damage or unusual wear observed. Inspect for stability, damage and excessive wear and utilize maintenance funds for any repairs needed between replacement cycles. Replacement cycles vary depending on the amount of use/abuse; however expect extensive park area renovation at roughly the time frame listed below.

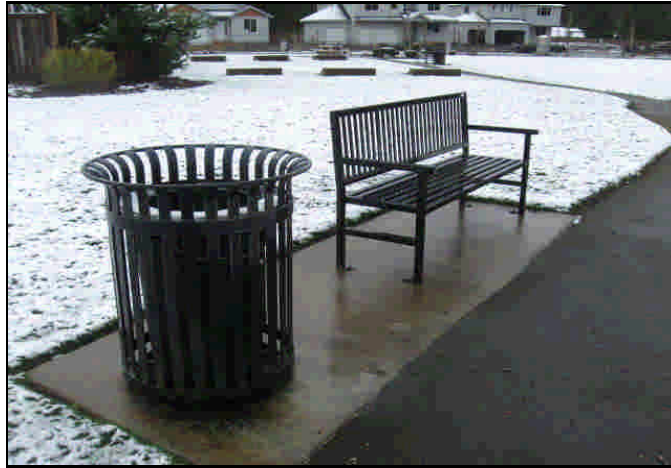
**Comp #: 346 Outdoor Furniture - Replace**

Evaluation: Good condition noted of picnic tables, benches and trash receptacles; no significant damage or instability observed at this time. Inspect regularly, clean for appearance and repair as needed from general operating funds. Best to plan for regular intervals of replacement at roughly the time frame indicated below to maintain functionality and a quality appearance.

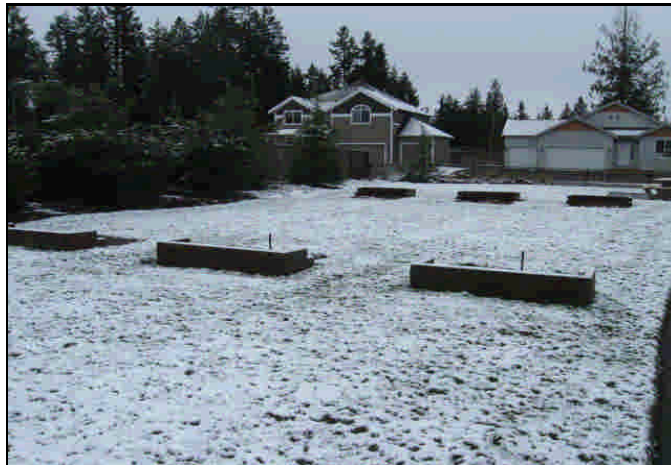
**Comp #: 350 Horseshoe Pits - Maintain**

Evaluation: Horseshoe pits appear to be in good, usable condition. These items are a minor expense and should be maintained out of the operating budget, not reserves.

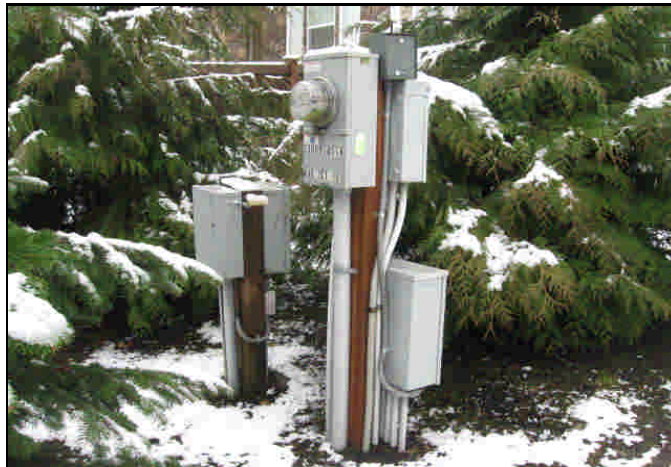
**Comp #:** 905 Electrical Systems - Repair/Replace

**Evaluation:** Analysis of electrical system(s), beyond visual inspection, is not within the scope of a reserve study. We were informed of ongoing issues with the electrical system at the entry monument lighting, which will be addressed and funded for as part on the entry monument replacement project.

Typically, if installed per architectural specifications, building codes, and electric codes, without defect, there is no predictable time frame for large scale repair/replacement expenses within the scope of our review. Treat minor repairs as ongoing maintenance expense.

Some electrical system components used historically are known to be life limited. Manufacturing defects can become apparent from time to time and certain site conditions can contribute to premature deterioration of system components. Periodic inspections and maintenance by an electrician may be wise operating expense. Some associations employ infrared or other testing methodologies to identify potential trouble spots.

A good resource book available for purchase is NFPA 70B Recommended Practices for Electrical Equipment Maintenance. Funding may be incorporated into future reserve study updates if conditions change. No basis for reserve funding at this time.
